5.4L INTERMITTENT RATTLE NOISE / ROUGH IDLE WHEN ENGINE IS AT OPERATING TEMPERATURE

TSB 12-7-10

FORD:

2004-2010 F-150
2005-2010 F-250, F-350
2005-2012 Expedition

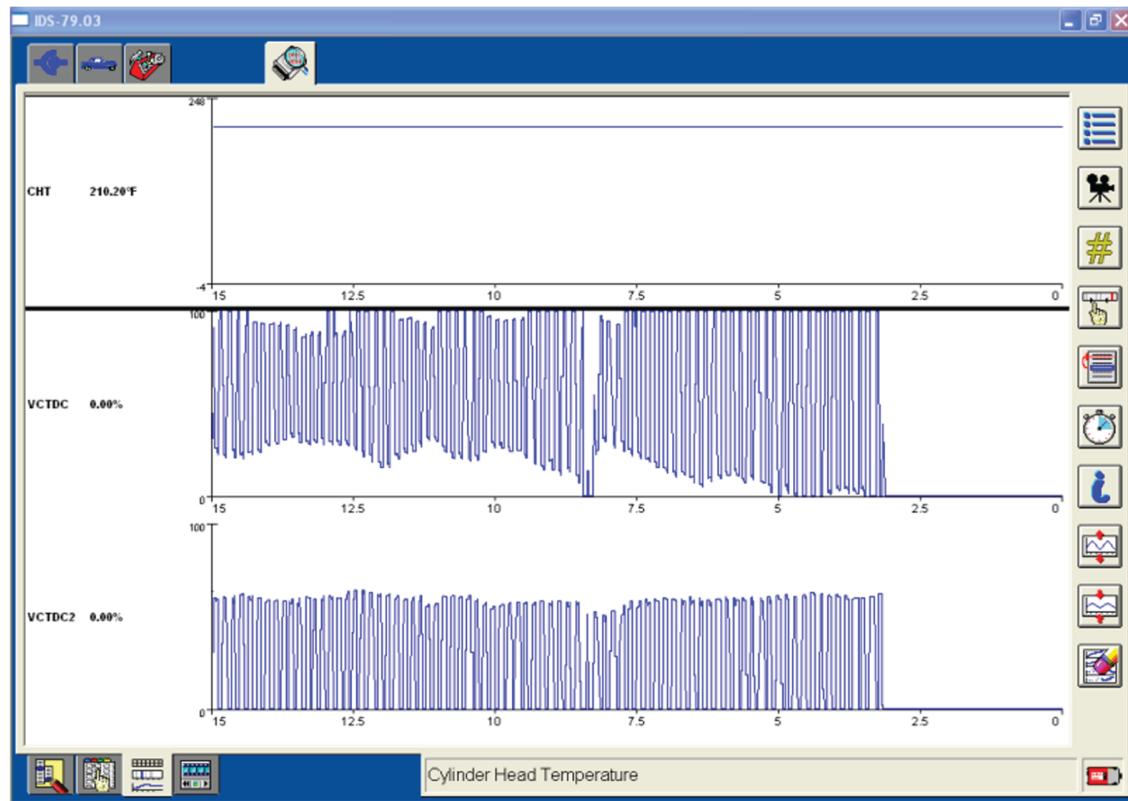
Figure 1 - Article 12-7-10

Some 2004-2010 F-150, 2005-2010 F-Super Duty, 2005-2012 Expedition, Navigator and 2006-2008 Mark LT vehicles equipped with a 5.4L 3V engine may exhibit an intermittent rattle noise/rough idle when engine is at operating temperature. The issue is caused by oscillating cam timing, diagnostic trouble codes (DTCs) P0022, P0021, P0340, and/or P0341 may be stored in the powertrain control module (PCM).

- a. Start IDS
 - b. Select Data Logger
 - c. Select PIDs VCTDC, VCTDC2, and CHT
2. With the engine idling at normal operating temperature CHT above 93 °C (200 °F) apply the parking brake and hold service brake pedal firmly with transmission selector lever in (D). Raise engine RPMs from idle to approximately 1500 RPMs and release the throttle. Does the vehicle exhibit a rattle type noise with a rough idle and are the cam solenoid duty cycle PID values oscillating after RPMs return to idle speed? (Figure 1)

- a. Yes - Proceed to Step 3.
- b. No - This article does not apply. Refer to Workshop Manual (WSM), Section 303-00 for normal diagnostics.
3. Replace both the left and right Variable Camshaft Timing (VCT) Oil Control solenoids. Refer to WSM, Section 303-04B for 2004 vehicles OR 303-14 for 2005-2012 vehicles.
